Southern Sydney Freight Line Environmental Protection Licence Monthly Report

October 2009

Document Status	
Project:	ARTC
	Southern Sydney Freight Line
Document:	EPL 12971 Monthly Report – October 2009

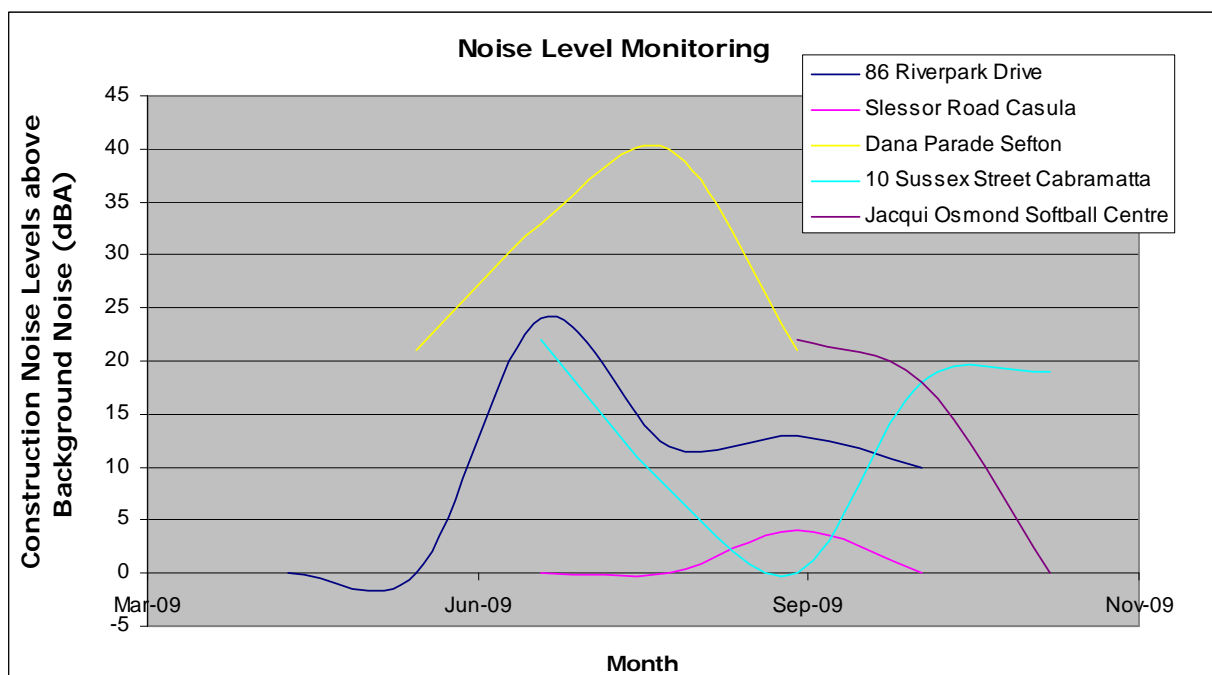
Figure 1: Noise Monitoring Trend Summary

Condition R.41(c) of the EPL requires that ARTC provide graphical representations of noise monitoring results obtained over the life of the project. Noise monitoring locations vary from month to month. Sufficient data has now been gathered at: 86 Riverpark Drive, Slessor Road Casula, Dana Parade Sefton Drive, 10 Sussex Street Cabramatta and the Jacqui Osmond Softball Centre for trends to be observed. The results of the noise variations at these sites over the last 6 months are displayed graphically below. Appendix A includes a comprehensive list of locations where noise monitoring has been undertaken.

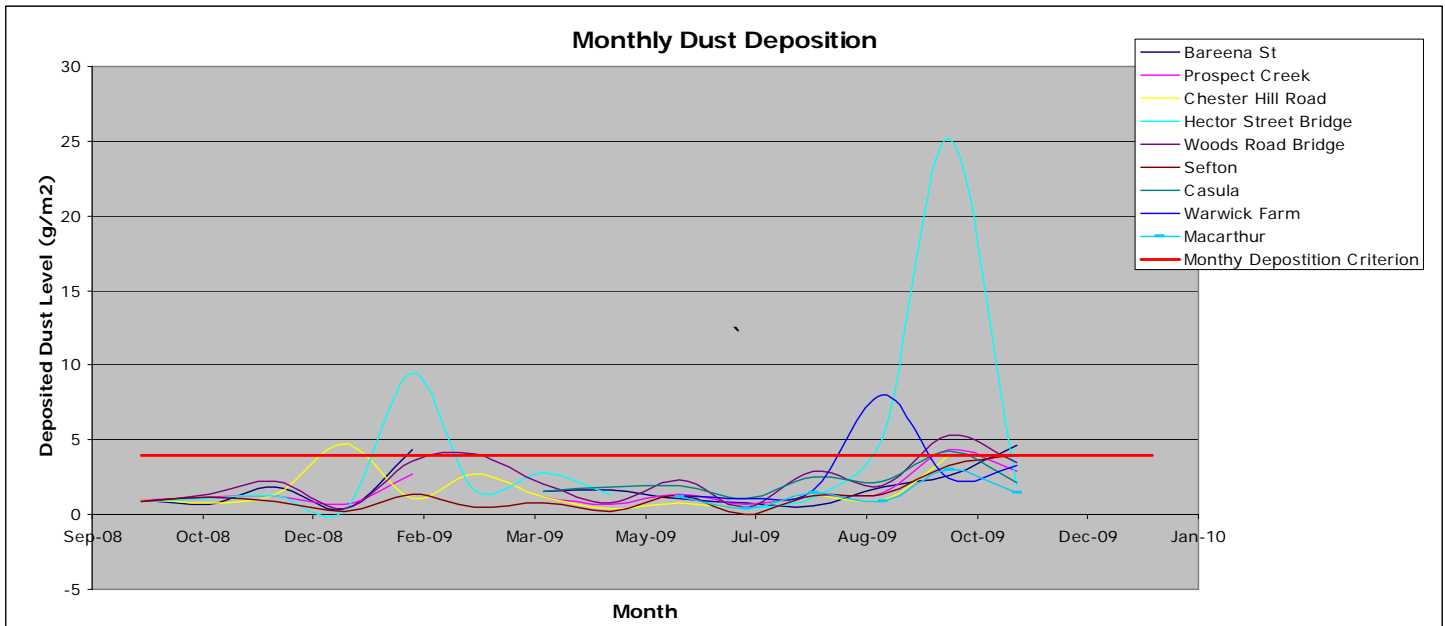
In accordance with requirements set out under R4.1(c) of the license, ARTC has prepared a graphical representation of monthly dust deposition results measured at the following project sites:

The results show that the level of deposited dust along the length of the SSFL Project, during the month of October was below the maximum total deposited dust level of 4g/m²/month, stipulated in the DECC's Approved Methods for Modelling and Assessment of Air Pollutants in NSW (2005), at all locations except Bareena Street Bridge.

Increased deposited dust at Bareena Street Bridge, where the total level was 4.6 g /m² /month, was the result of new earthmoving works commencing in the vicinity. Arenco, the Contractor responsible, has advised that this activity has been suspended and intend to vegetate the area by hydro-seeding.
