Southern Sydney Freight Line Environmental Protection Licence Monthly Report

September 2009

Document Status	
Project:	ARTC
	Southern Sydney Freight Line
Document:	EPL 12971 Monthly Report – September 2009

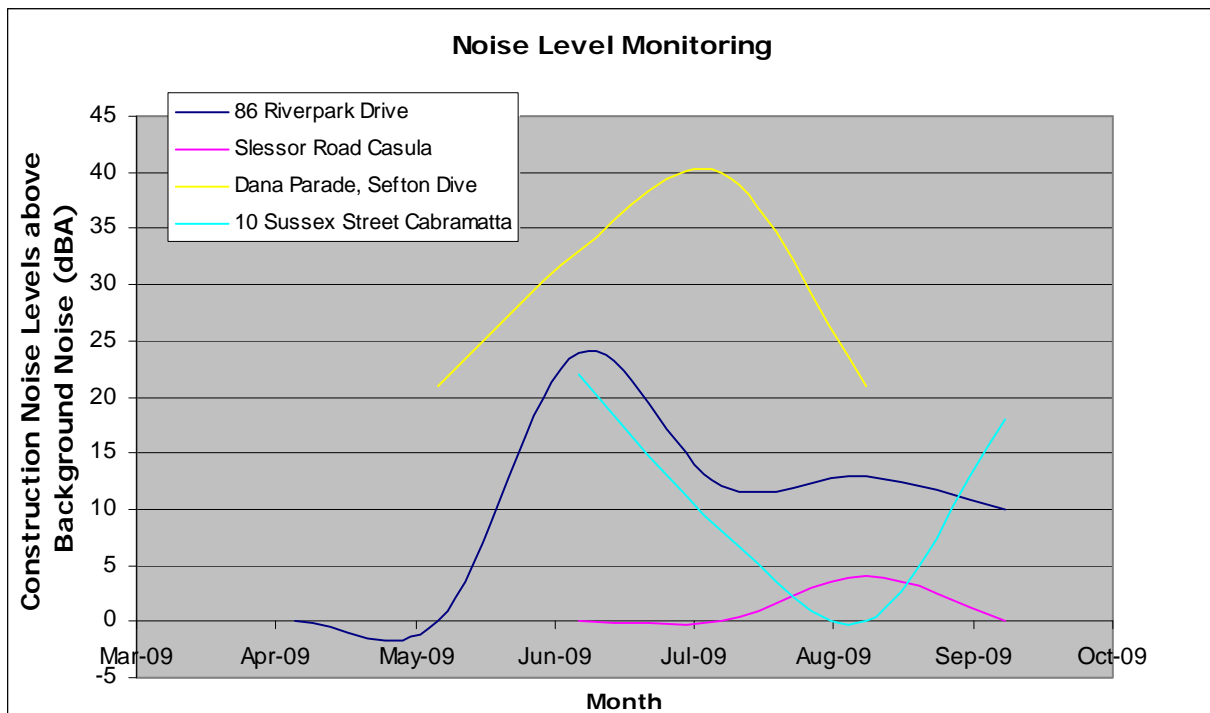
Figure 1: Noise Monitoring Trend Summary

Condition R.41(c) of the EPL requires that ARTC provide graphical representations of noise monitoring results obtained over the life of the project. Noise monitoring locations vary from month to month. Sufficient data has now been gathered at: 86 Riverpark Drive, Slessor Road Casula, Dana Parade Sefton Dive and 10 Sussex Street Cabramatta for trends to be observed. The results of the noise variations at these sites over the last 6 months are displayed graphically below. Appendix A includes a comprehensive list of locations where noise monitoring has been undertaken.

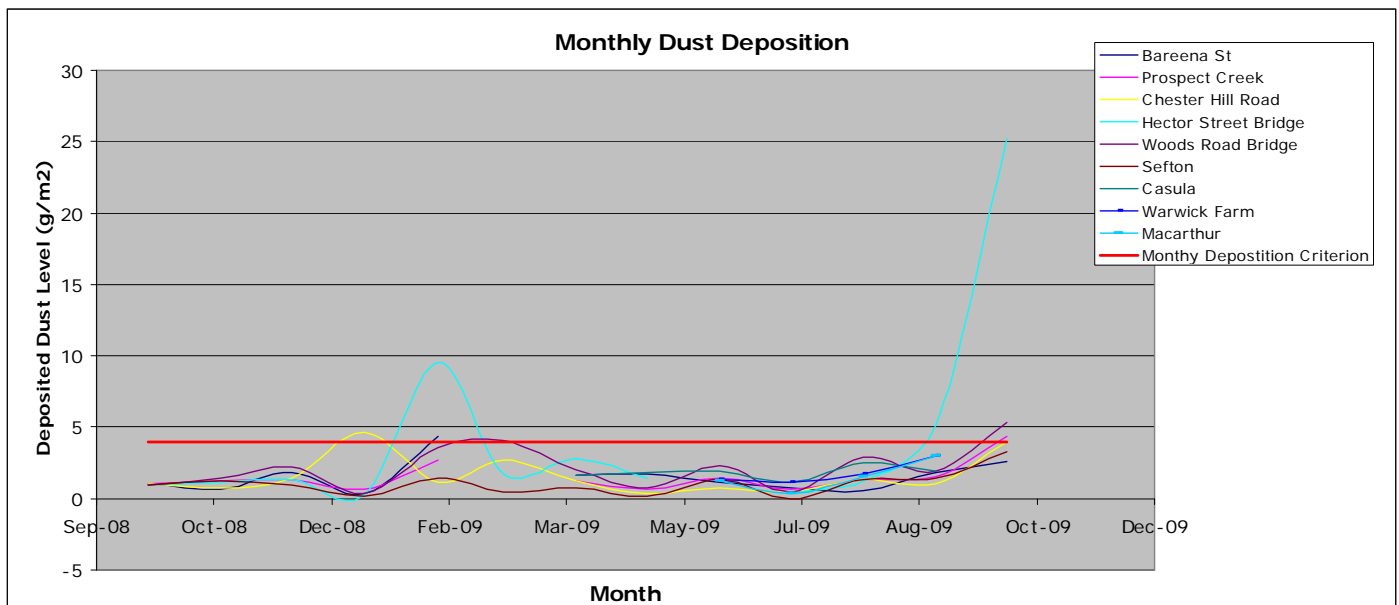
The results show that the level of deposited dust along the length of the SSFL Project, during the month of September was below the maximum total deposited dust level of 4g/m²/month, stipulated in the DECC's Approved Methods for Modelling and Assessment of Air Pollutants in NSW (2005), at all locations except Prospect Creek Bridge, Hector Street Bridge and Woods Road Bridge. At the time of preparation of this report, dust monitoring reports had not been received for the southern project areas of Warwick Farm, Casula and Macarthur.

It should be noted that dust monitoring during September 2009 was compromised by two severe dust storms: on Wednesday 23rd September and Saturday 26th September.

It should further be noted that the dust monitoring gauge at the Hector Street is positioned below road level and most likely captures dust emitted both from excavation work and substantial track movements taking excavated material from the site. This monitor was relocated to a more suitable location at the end of September 2009 contributing to a significantly high dust reading.
