# Southern Sydney Freight Line Environmental Protection Licence Monthly Report

**November 2009**

Document Status	
<b>Project:</b>	ARTC
	Southern Sydney Freight Line
<b>Document:</b>	EPL 12971 Monthly Report – November 2009

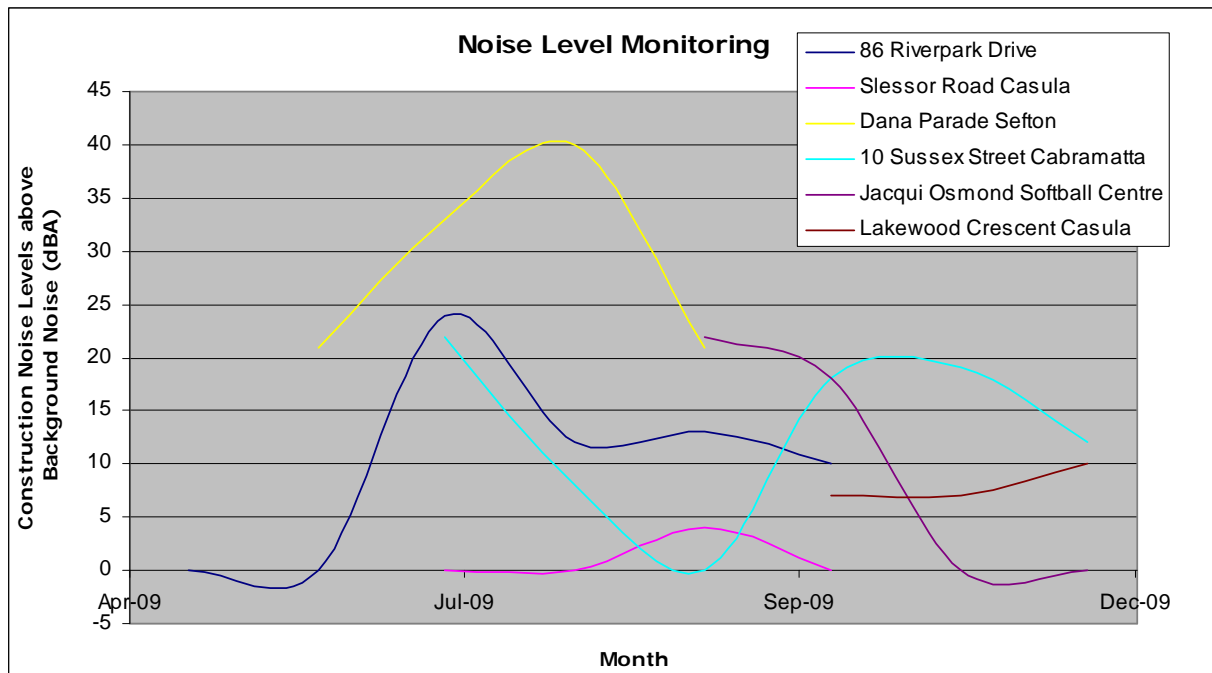
Figure 1: Noise Monitoring Trend Summary

Condition R.41(c) of the EPL requires that ARTC provide graphical representations of noise monitoring results obtained over the life of the project. Noise monitoring locations vary from month to month. Sufficient data has now been gathered at: 86 Riverpark Drive, Slessor Road Casula, Dana Parade Sefton Dive, 10 Sussex Street Cabramatta, Jacqui Osmond Softball Centre and Lakewood Crescent Casula for trends to be observed. The results of the noise variations at these sites over the last 6 months are displayed graphically below. Appendix A lists the locations where noise monitoring has occurred.

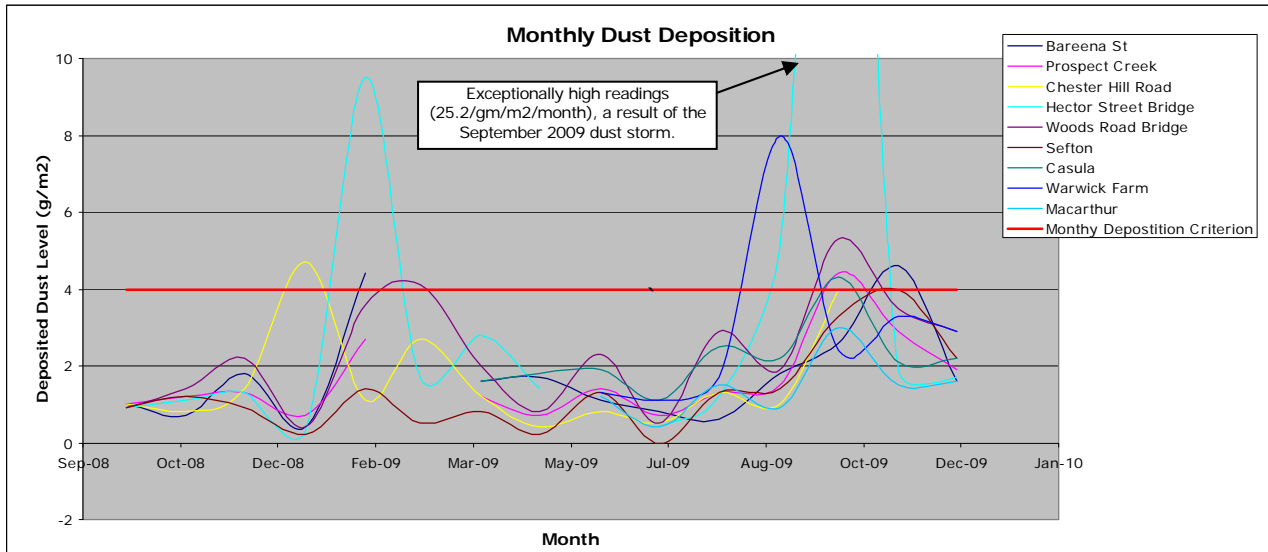
In accordance with requirements set out under R4.1(c) of the license, ARTC has prepared a graphical representation of monthly dust deposition results measured at the following project sites:

The results show that the level of deposited dust along the length of the SSFL Project, during the month of November was below the maximum total deposited dust level of  $4\text{g/m}^2/\text{month}$ , stipulated in the DECC's Approved Methods for Modelling and Assessment of Air Pollutants in NSW (2005) at all locations.
